INDOOR AIR QUALITY ASSESSMENT

**New Shrewsbury High School
Cypress Avenue
Shrewsbury, Massachusetts**

Prepared by:
Massachusetts Department of Public Health
Bureau of Environmental Health Assessment
June, 2002

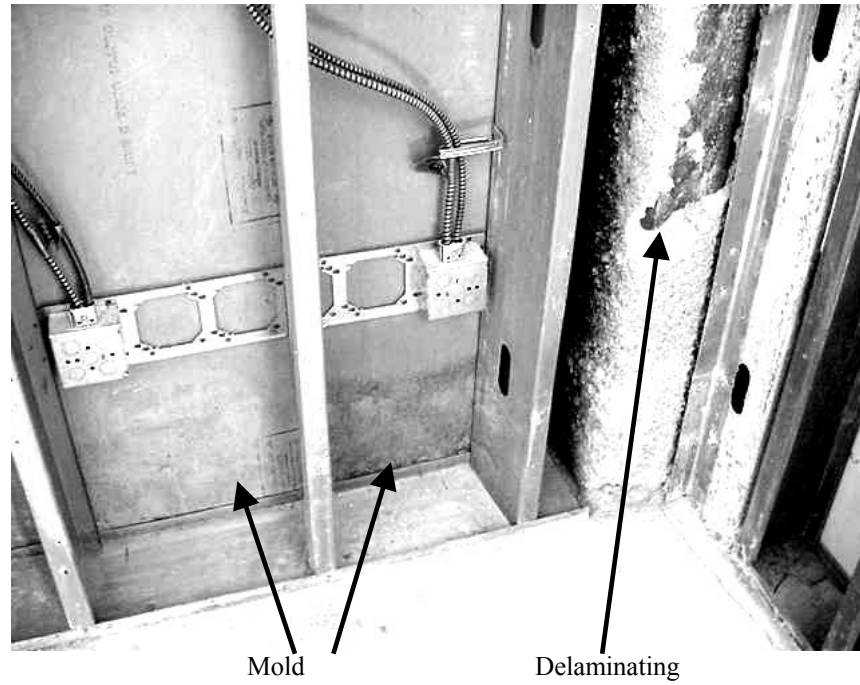
Picture 1

Moisture measurements were taken in GW of various areas with a documented history of water damage. In many areas GW did not have measurable moisture levels, however a total of 7 areas tested had moisture concentrations ranging from 0.1 to 0.4 percent. These moisture concentrations were found in both GW along exterior walls, as well as GW making up interior dividing walls. Bare GW within the D235 section (see Picture 1) had a black material growing near the floor. This mold growth indicates that GW was saturated with water, resulting in the colonization of mold.

**Mold Contaminated Wallboard,
Note Delaminating of Fireproofing on Beam**

1. Previous recommendations of IEG and RWGS should be implemented.
2. All GW that show visible microbial growth should be replaced.
3. Consideration should be given to re-positioning the duct shown in Picture 7 to face north. One possible solution would be to install a revolving head roof ventilator to direct the duct opening opposite to the prevailing wind. Consideration should be given to inject fresh air into the duct to aid the univent's draw of outdoor air.

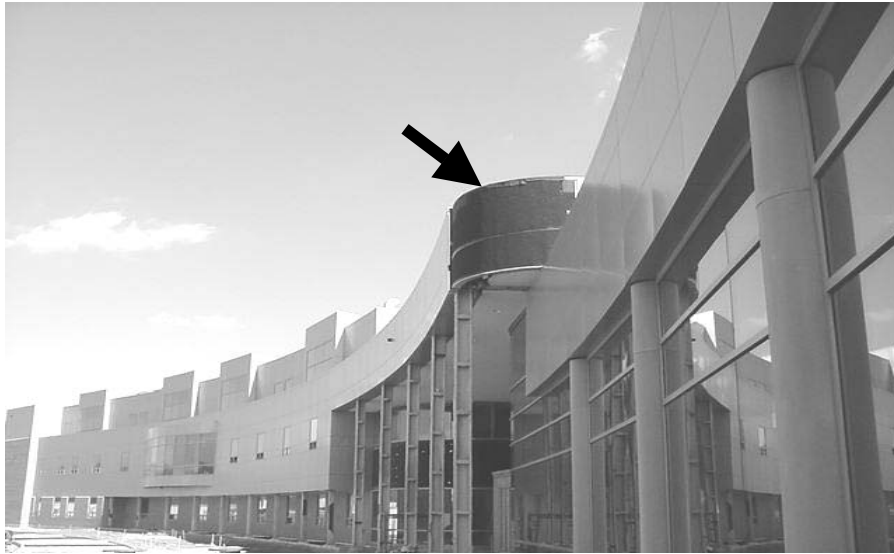
Picture 2

Several areas of the exterior wall system remain unfinished (see Pictures 2 through 6). These open breaches in the exterior wall system can be a source of water infiltration into the building during driving rain. Sealing the exterior wall system will serve to prevent further damage to interior walls.

Exterior of Front of Building near Lobby, Note Lack of Exterior Panels

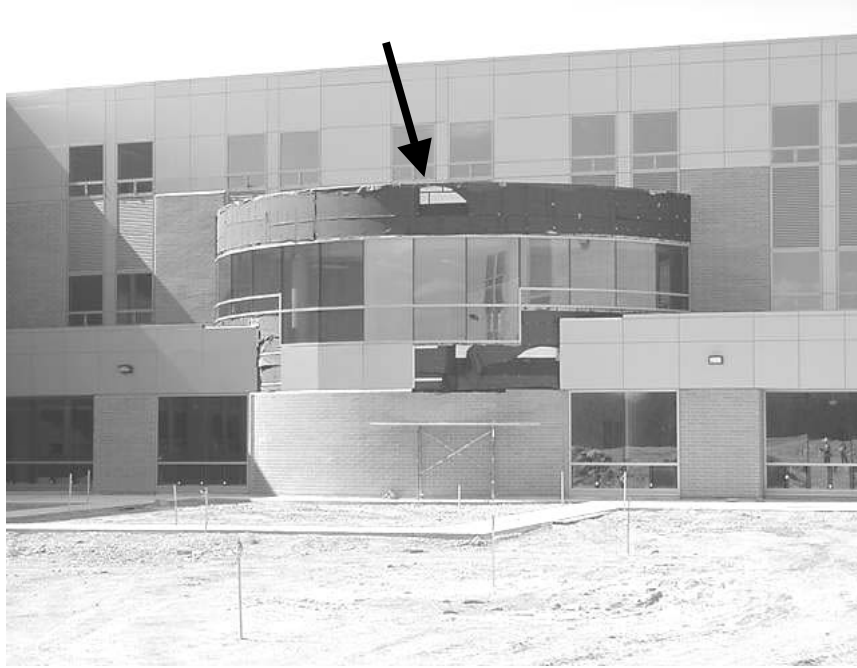
Picture 3

Rear Atrium in Courtyard on Back of Building, Note Lack of Exterior Panels and Peeled Felt

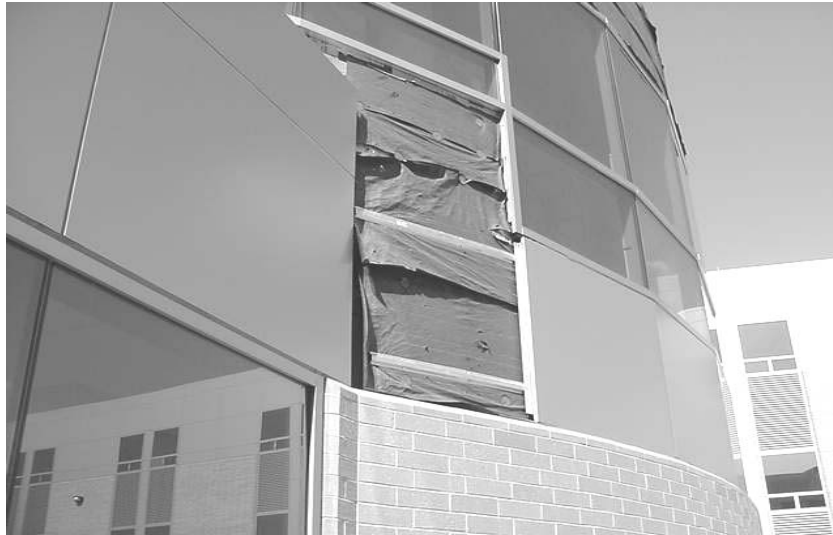
Picture 4

Rear Atrium in Courtyard on Back of Building, Note Lack of Exterior Panels and Peeled Felt

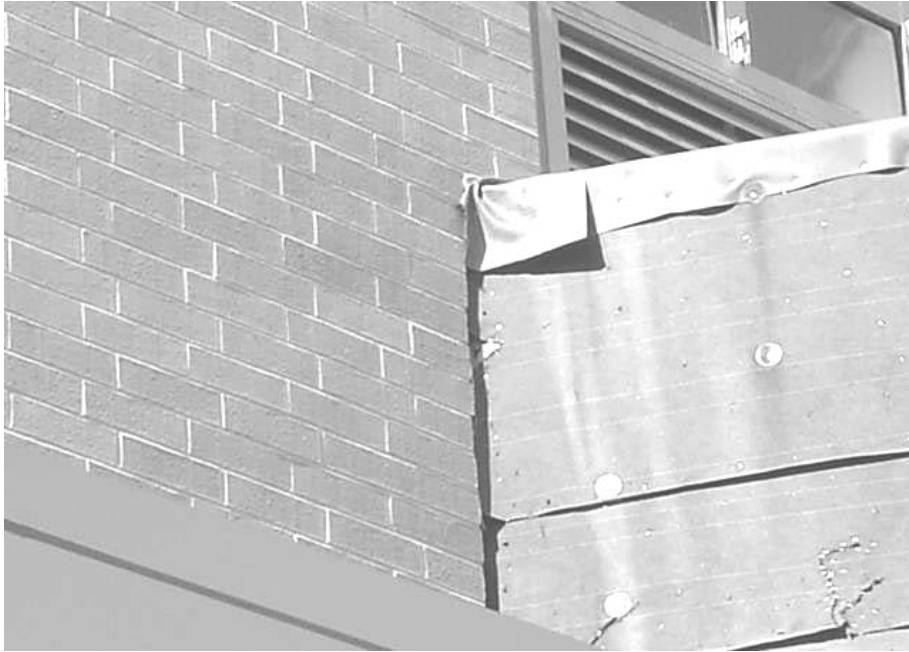
Picture 5

Close-up of Exposed Seam in Picture 4,

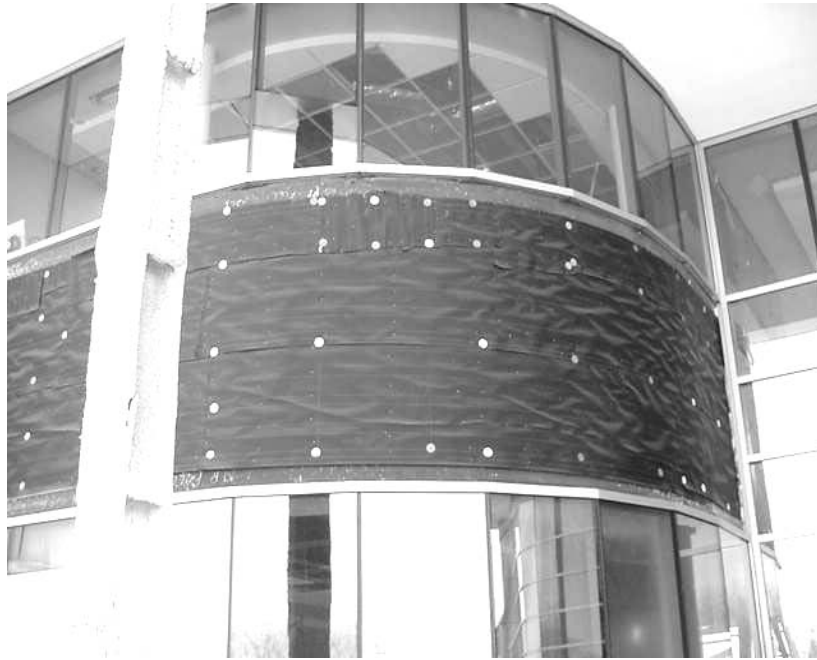
Picture 6

Exterior of Front of Building near Lobby, Note Lack of Exterior Panels

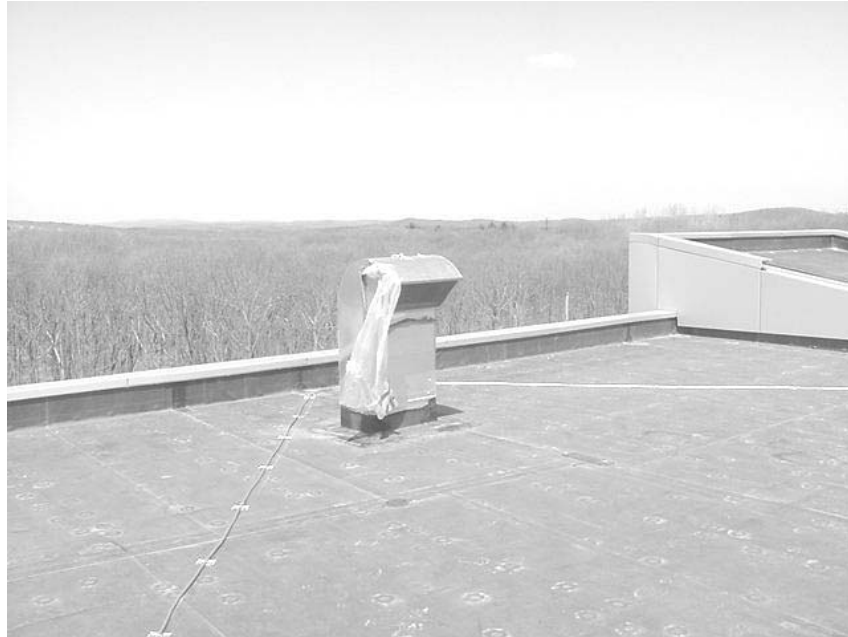
Picture 7

Several passive fresh air intakes exist of the roof with openings facing south (see Picture 7). Each of these vents are connected to unit ventilators for third floor classrooms. The location of the duct openings may make these vents prone to water penetration during rainstorms with a southwest wind. Water penetration into these vents may result in water accumulation in the base of ducts and lead to subsequent microbial growth within univents.

Passive Fresh Air Intake on Roof Facing South-South West
